# Stage 2 Social and Environmental Risk Assessment

## Wollongong Coastal Management Program

Wollongong City Council

| <b>Document Number</b> | 26050019_R01_V03 |

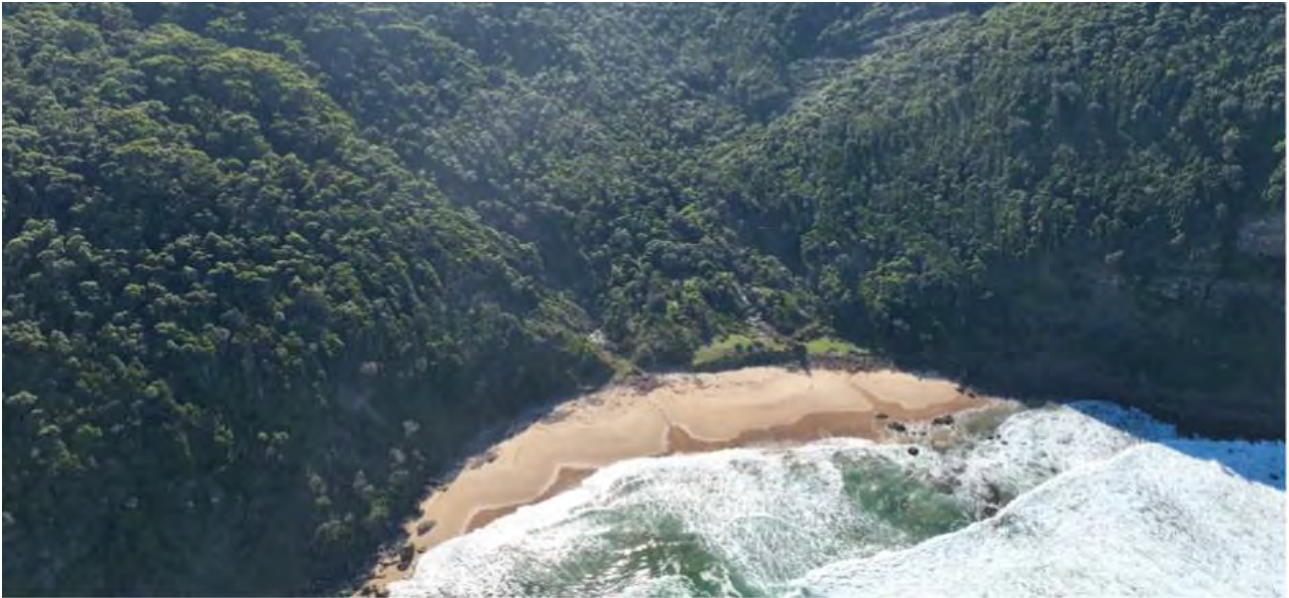
**Figure 3.4** Narrow beach width at Werrong (image source: Salients, 2026)

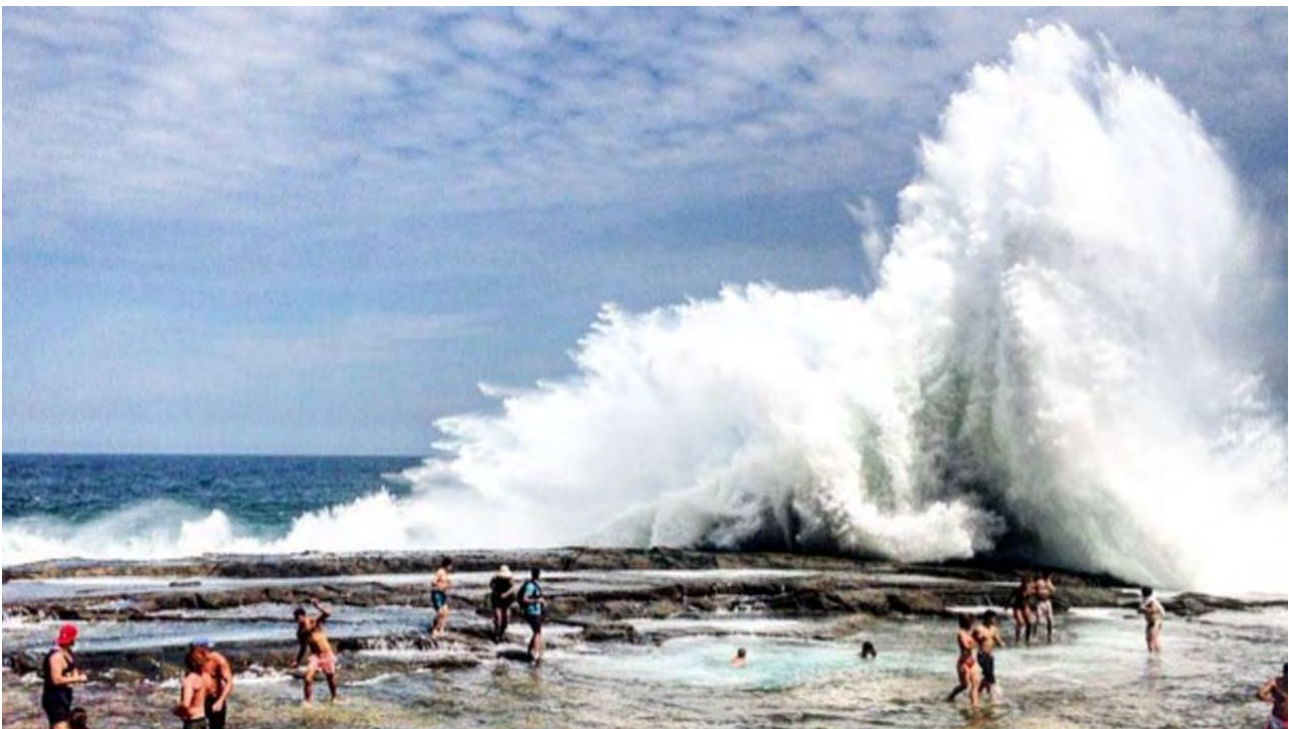
**Figure 3.5** Wave overtopping at the figure 8 rock pools (image source: Daily Telegraph)

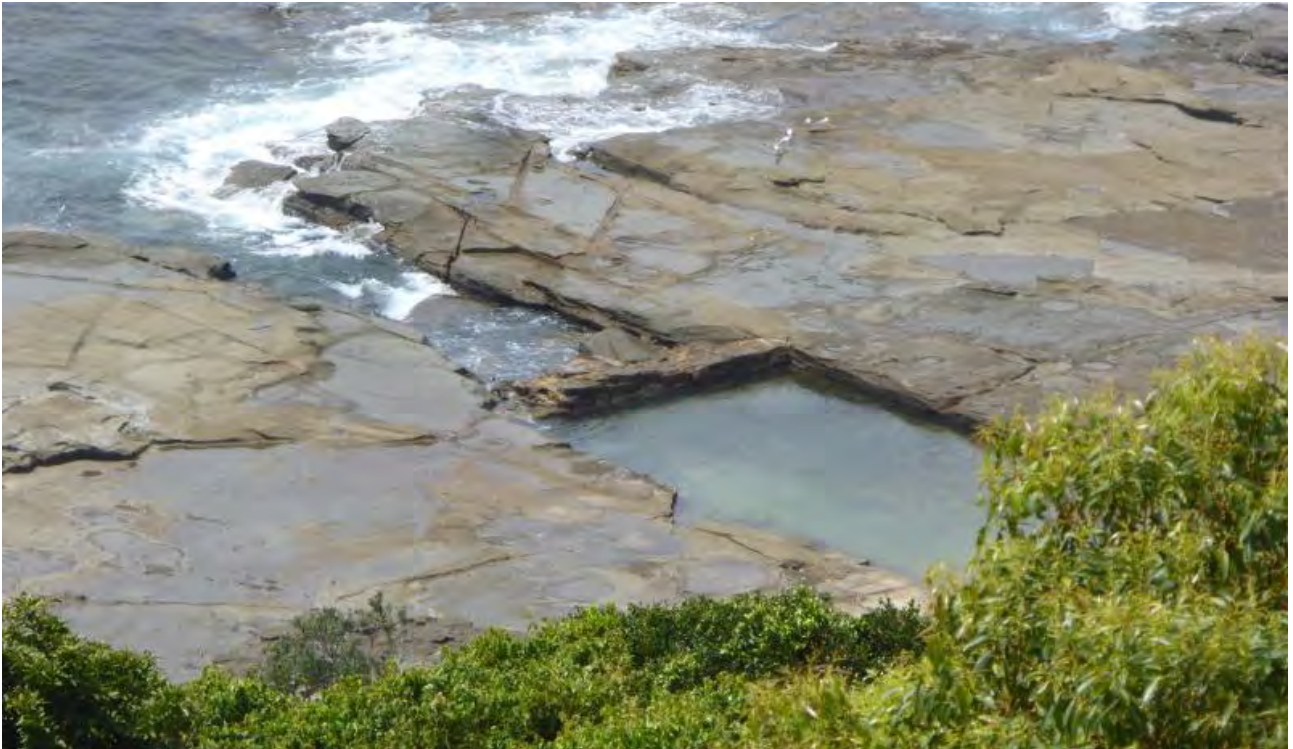
**Figure 3.6** The low lying Bulgo ocean pool (image source: OceanPoolsNSW)

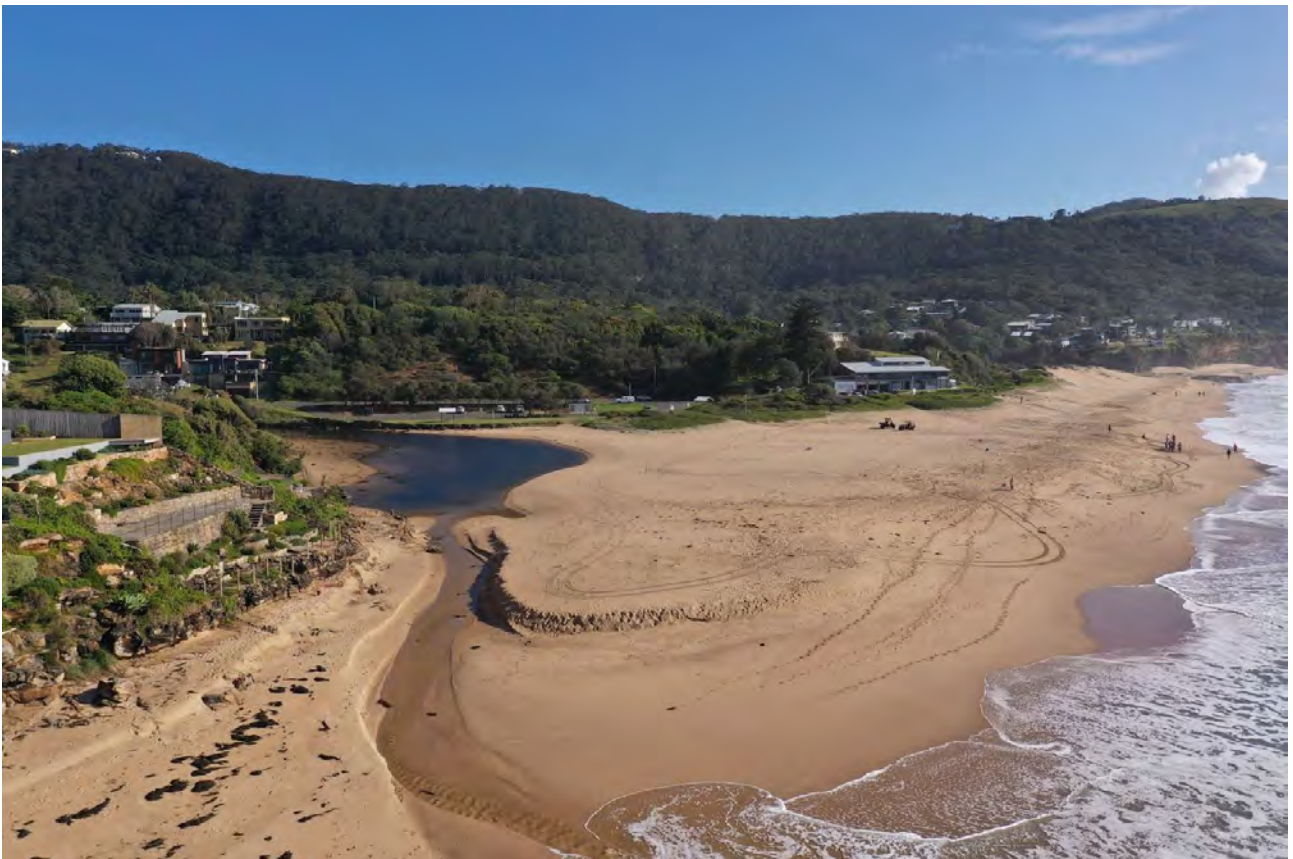
Figure 3.10 The entrance to Stanwell Creek at Stanwell Park Beach (image source: WCC)

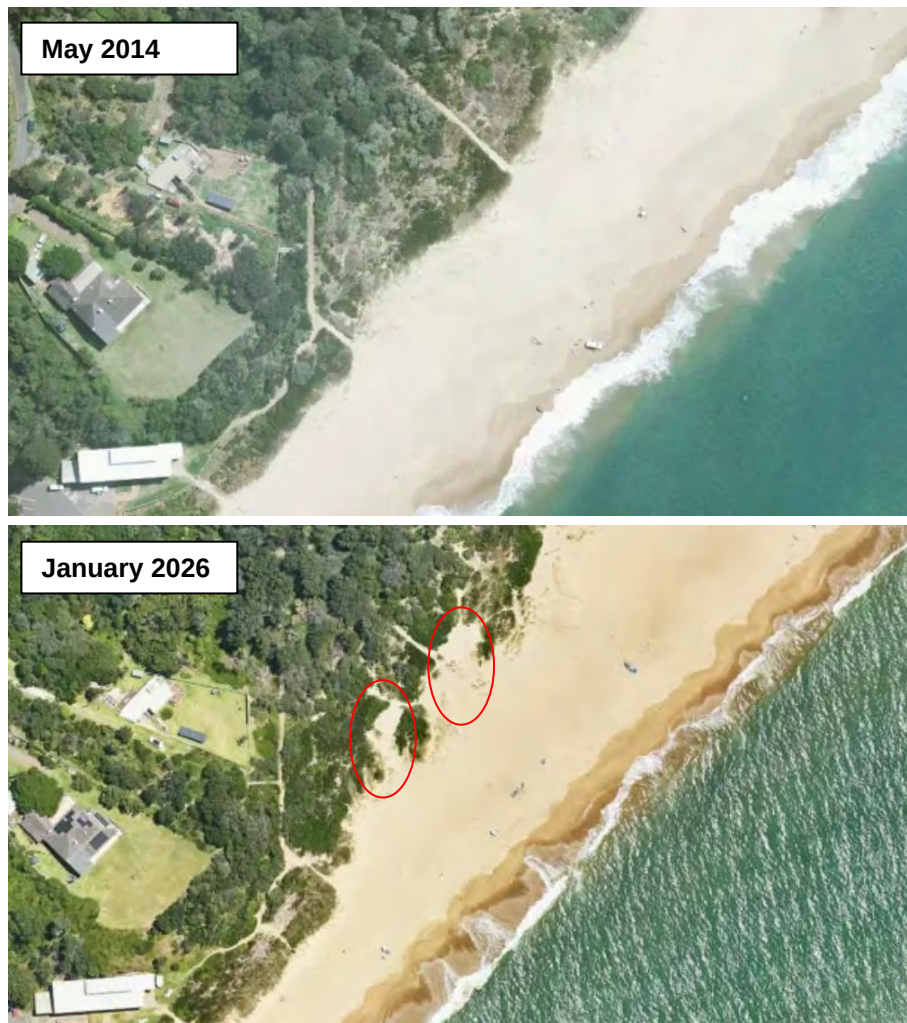
**Figure 3.13** Incipient dune blowout at the Stanwell Park dunes

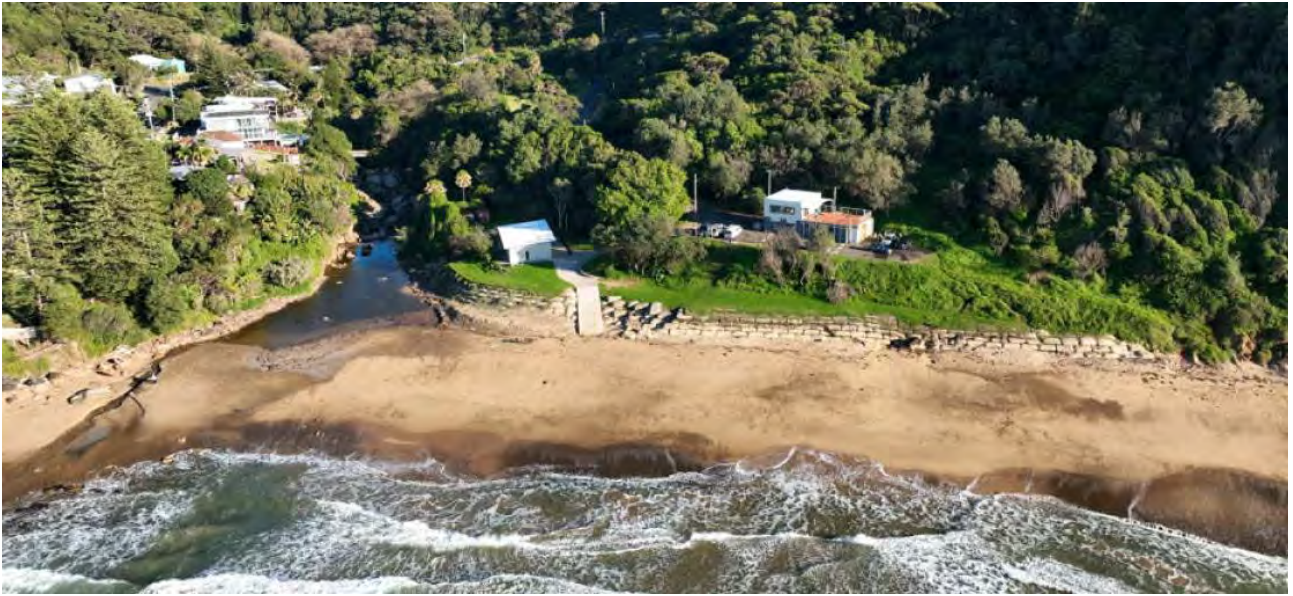
Figure 3.15 GSC seawall structure (image source: Salients, 2026)

- **Loss or rationalisation of SLSCs:** The Coalcliff SLSC is currently protected by the adjacent GSC coastal protection structure; however, sections of this structure show signs of deterioration. If the structure continues to degrade without maintenance or renewal, exposure of the SLSC and surrounding reserve infrastructure to coastal hazards may increase over time. The present-day risk is assessed as Low, increasing across longer planning horizons.

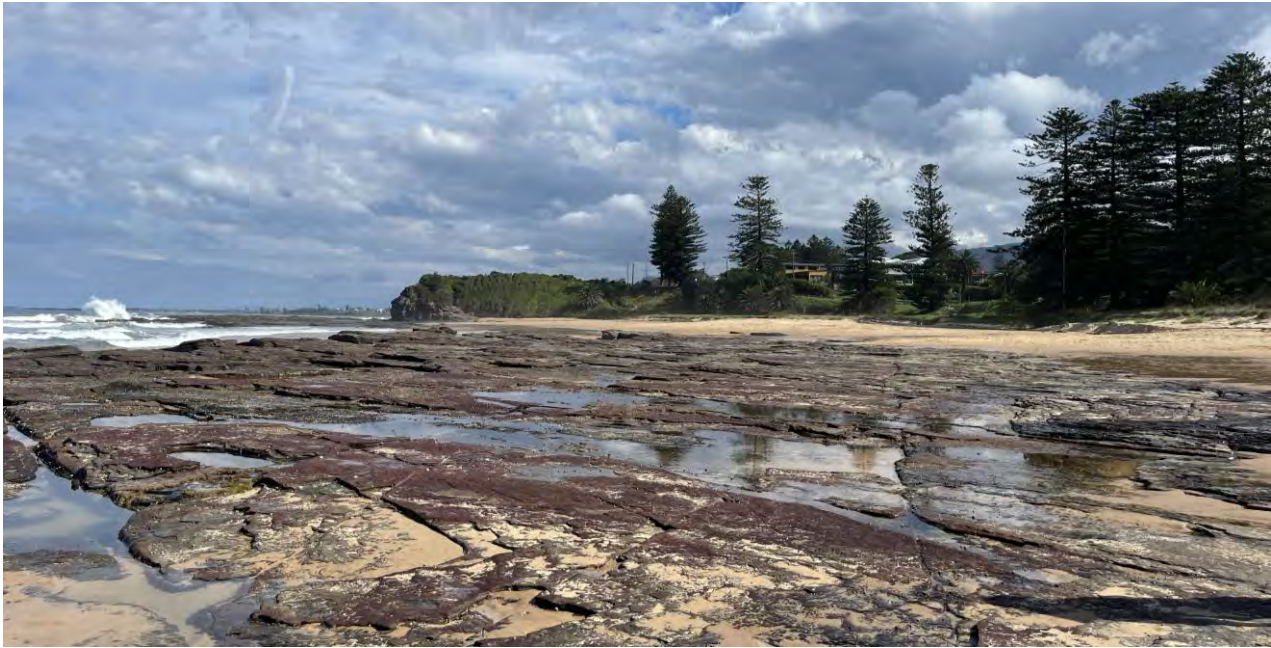
Figure 3.26 Loss of beach width at Little Austinmer beach after a storm event

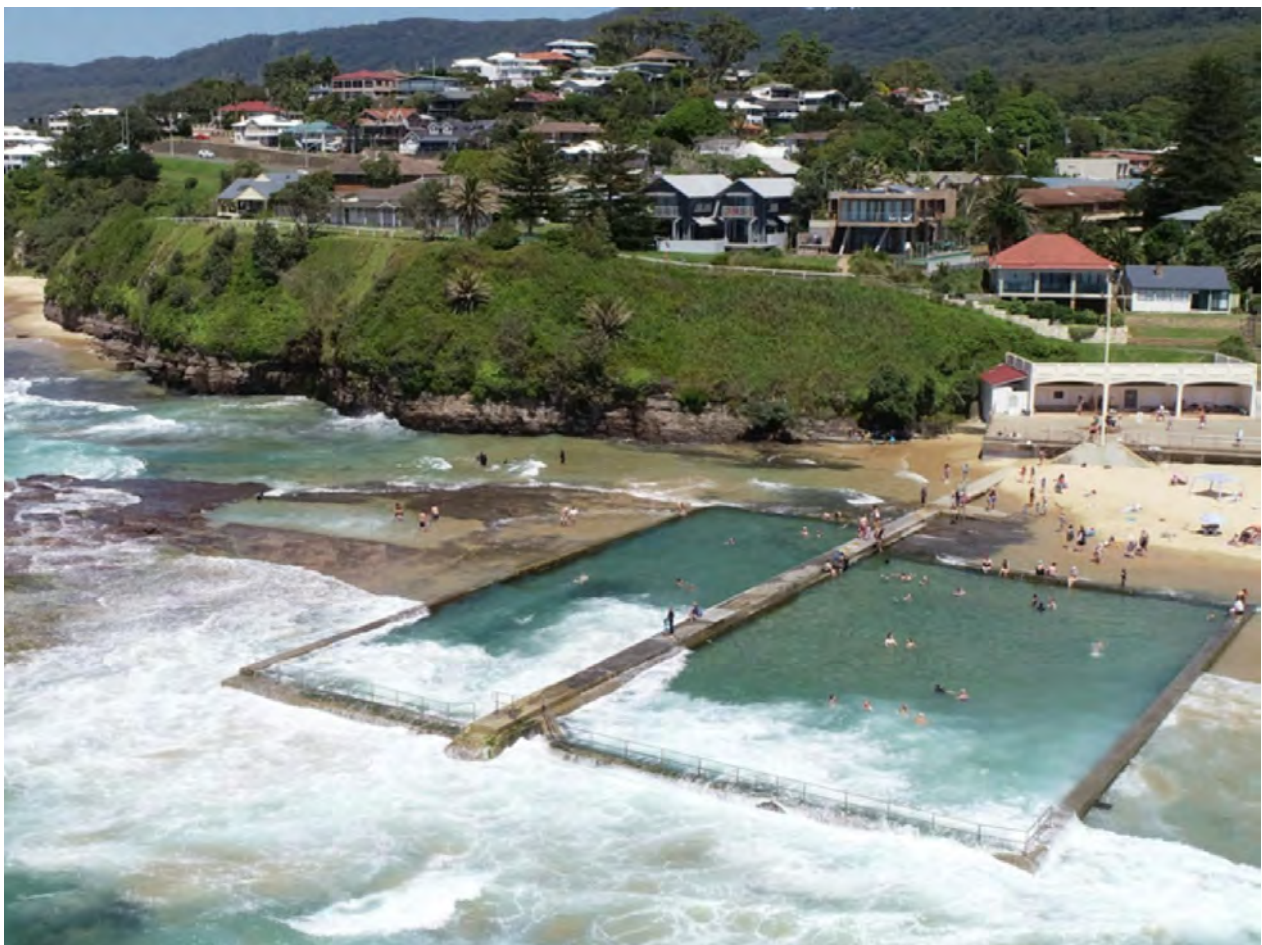
Figure 3.27 Wave overtopping of the Austinmer ocean pool (image source: WCC)

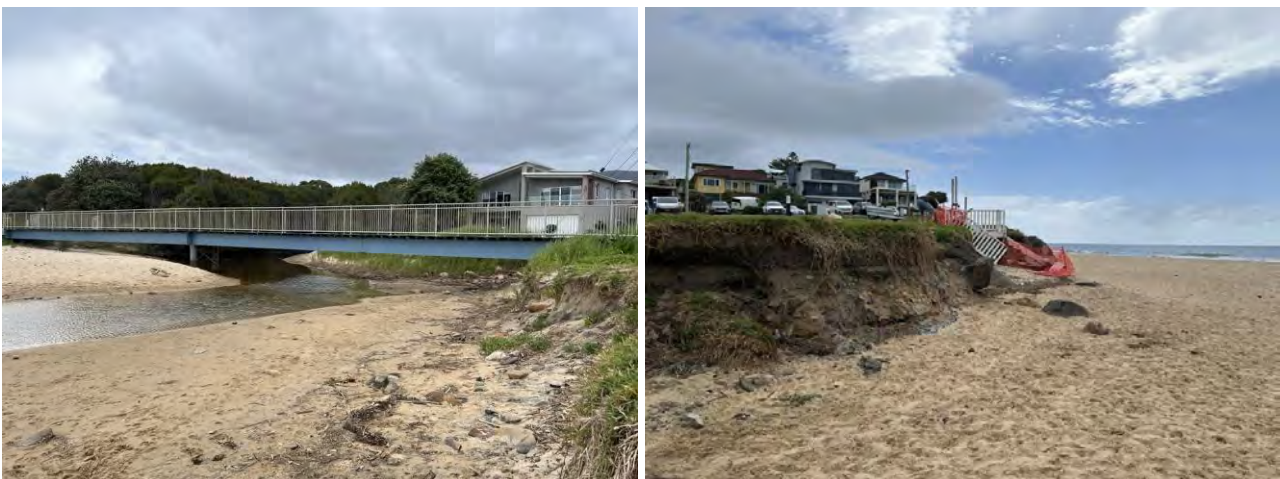
Figure 3.32 Entrance instability at Hewitts Creek impacting safe beach access. Image taken November 2025.

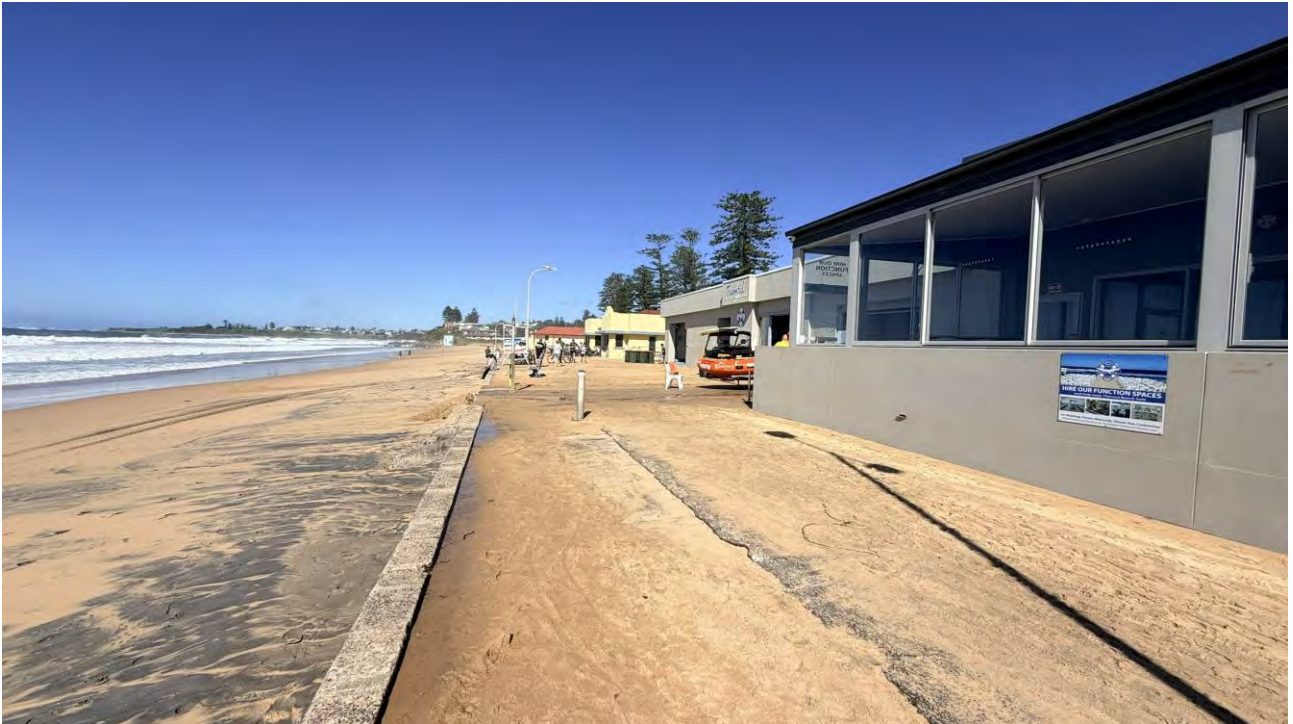
**Figure 3.33** Sand deposited at Thirroul promenade by high wave energy in April 2025

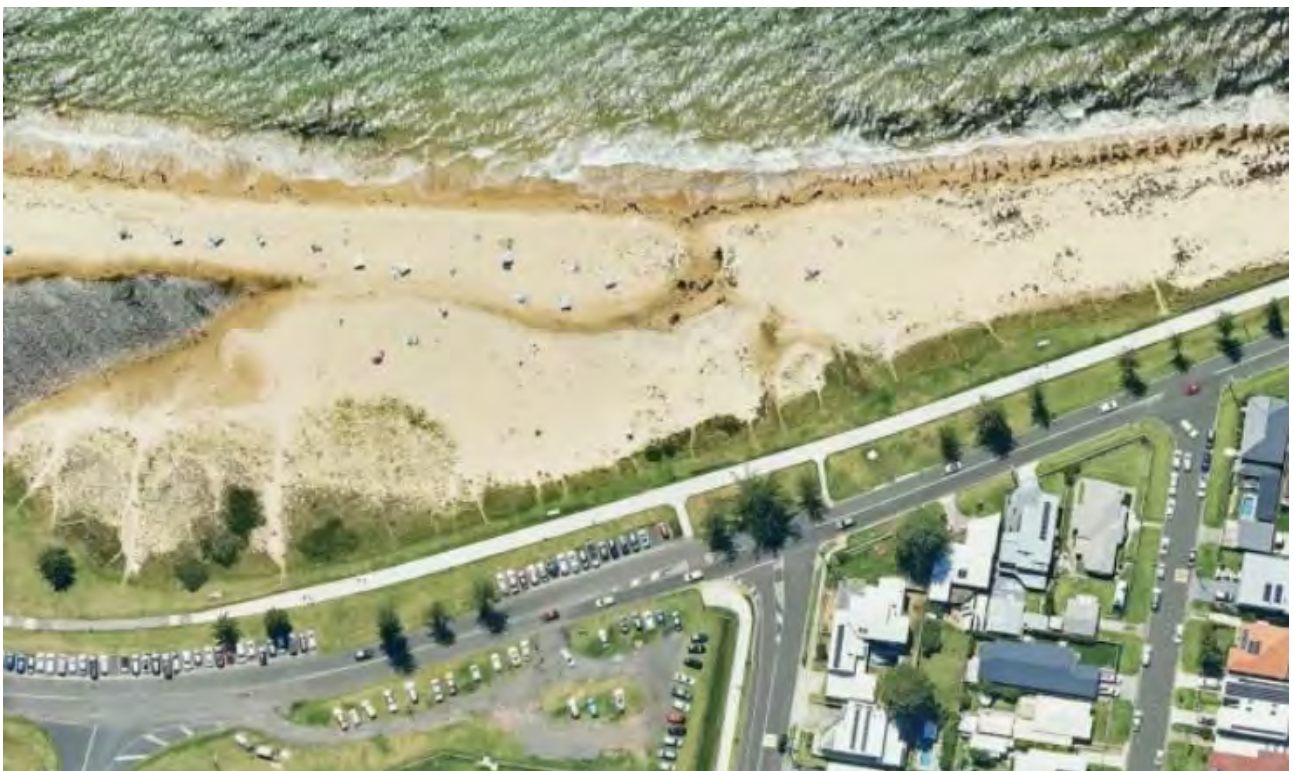
Figure 3.37 Informal access paths through the dunes at Sandon Point Beach

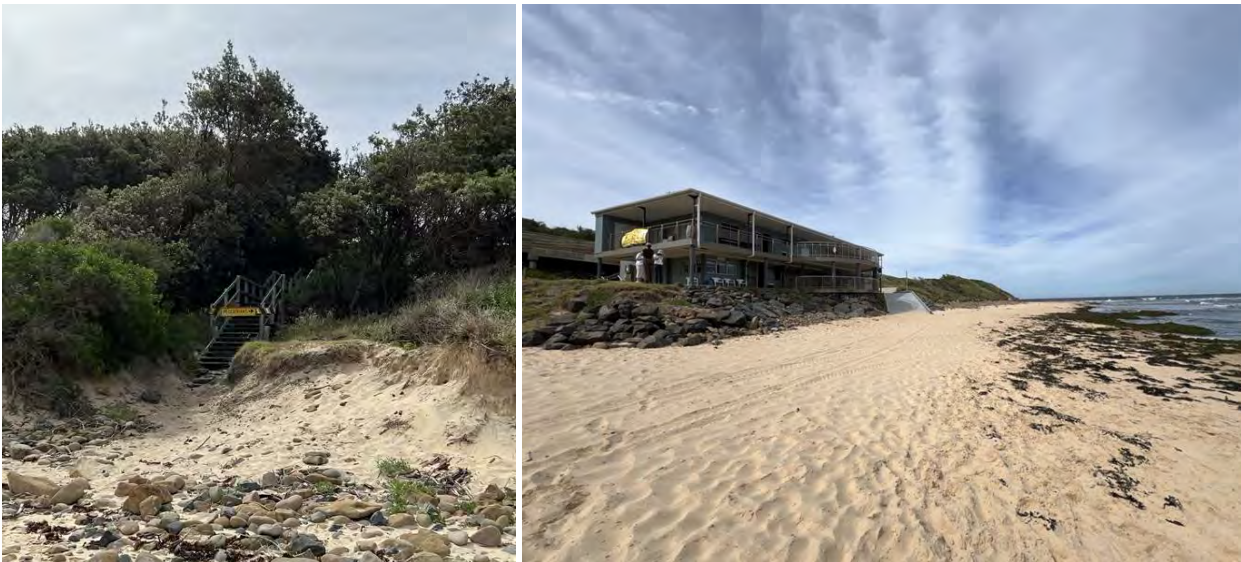
Figure 3.38 Sandon Point SLSC - reduced beach access (left) and exposure/proximity to wave overtopping (right)

- **Loss or rationalisation of SLSCs:** Sandon Point SLSC is located within the present-day coastal cliff and slope instability coastal hazard area (Salients, 2026) and may be exposed to slope instability during major storm events. Significant erosion could affect access to the facility or damage associated infrastructure. The present-day risk is assessed as Moderate, increasing across future planning horizons as coastal hazards intensify.

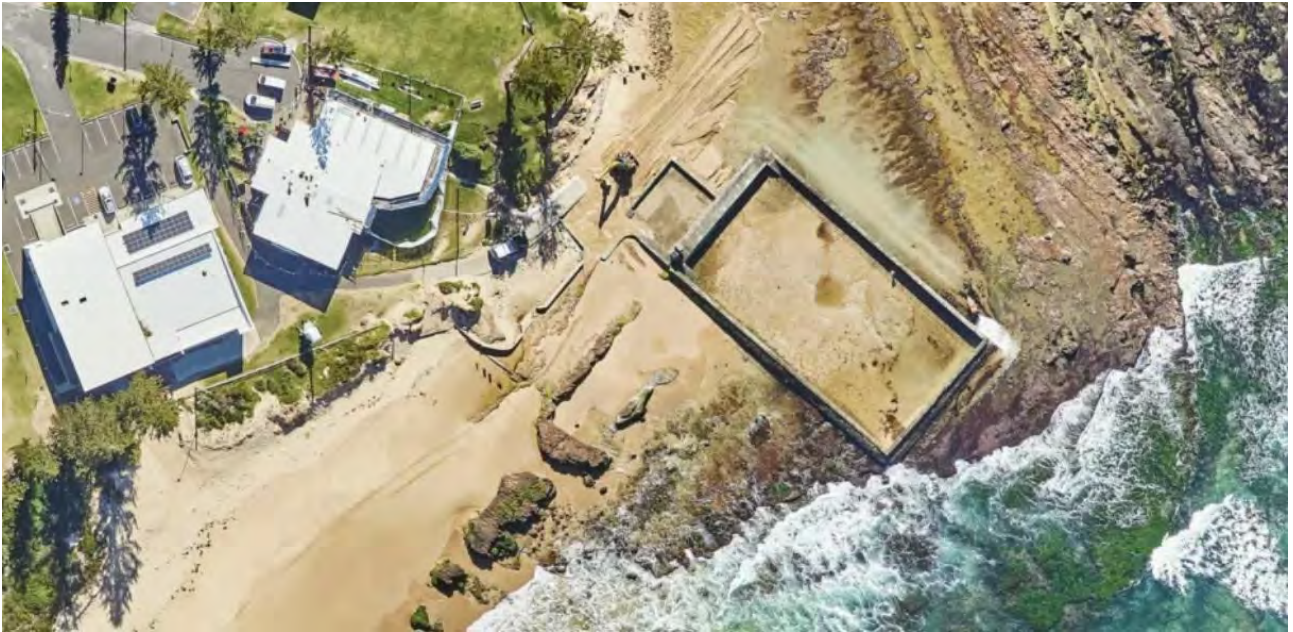
**Figure 3.39** Bulli Ocean Pool sand clearance works in July 2005 (image source: MetroMap)

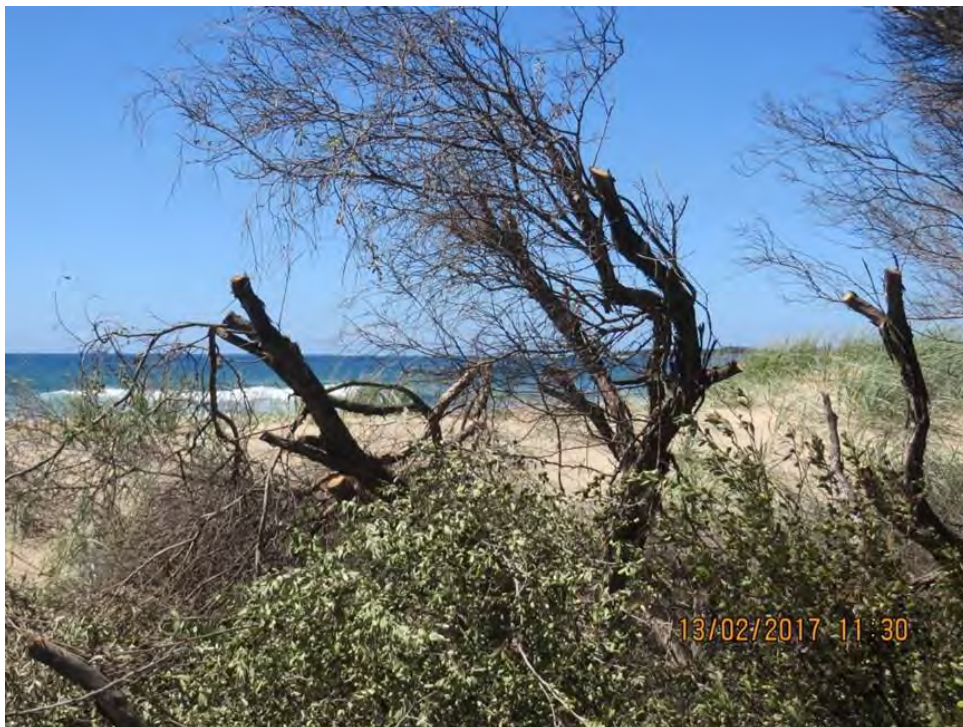
Figure 3.43 Woonona Beach - Vegetation vandalism resulting in loss of tree canopy along Kurraba Road

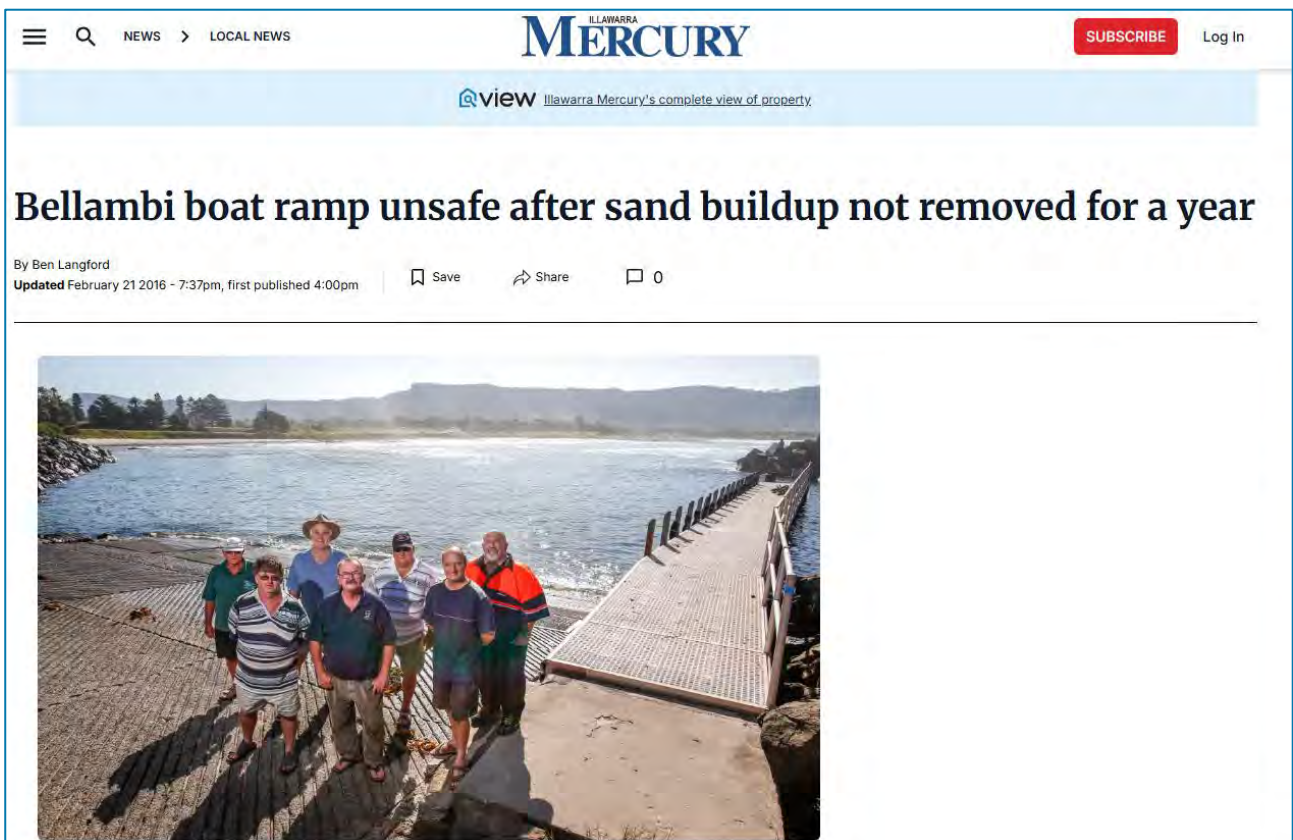
Figure 3.45 Bellambi Boat Ramp sedimentation raised as an issue in local media (image source: The Illawarra Mercury)

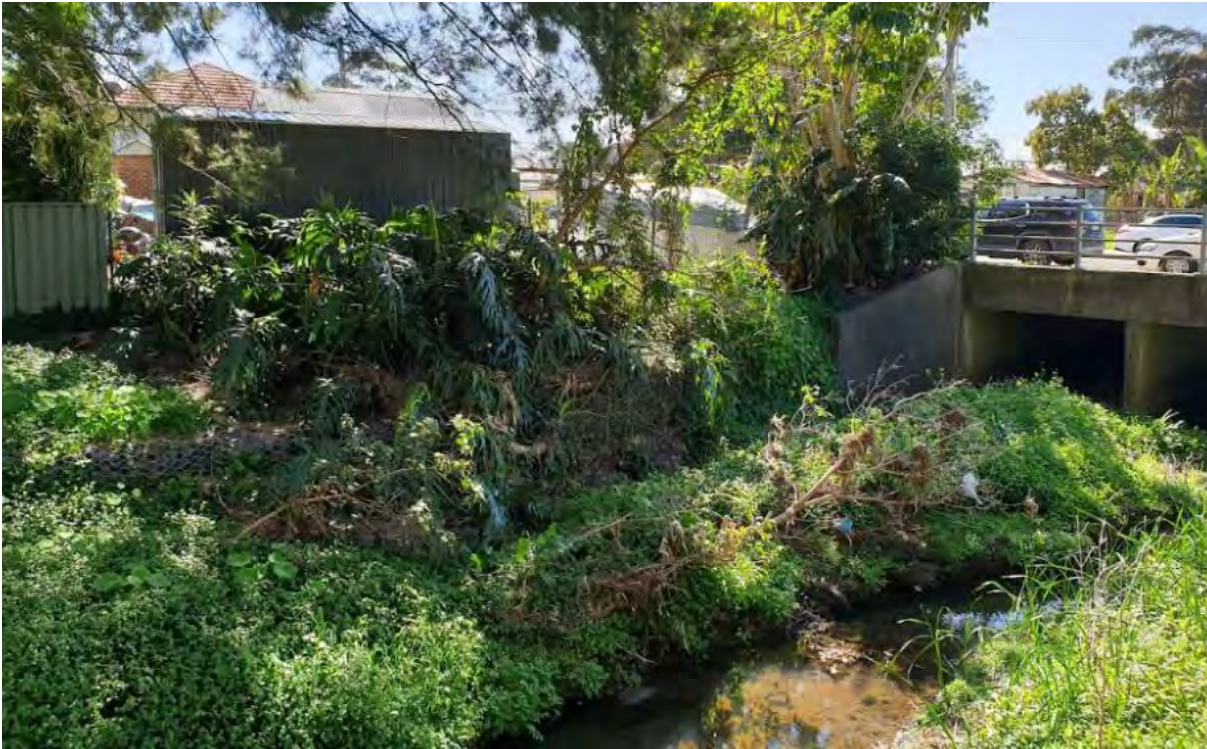
Figure 3.49 Exotics and invasive weed infestation along the Fairy Creek waterway (Good Bush, 2022)

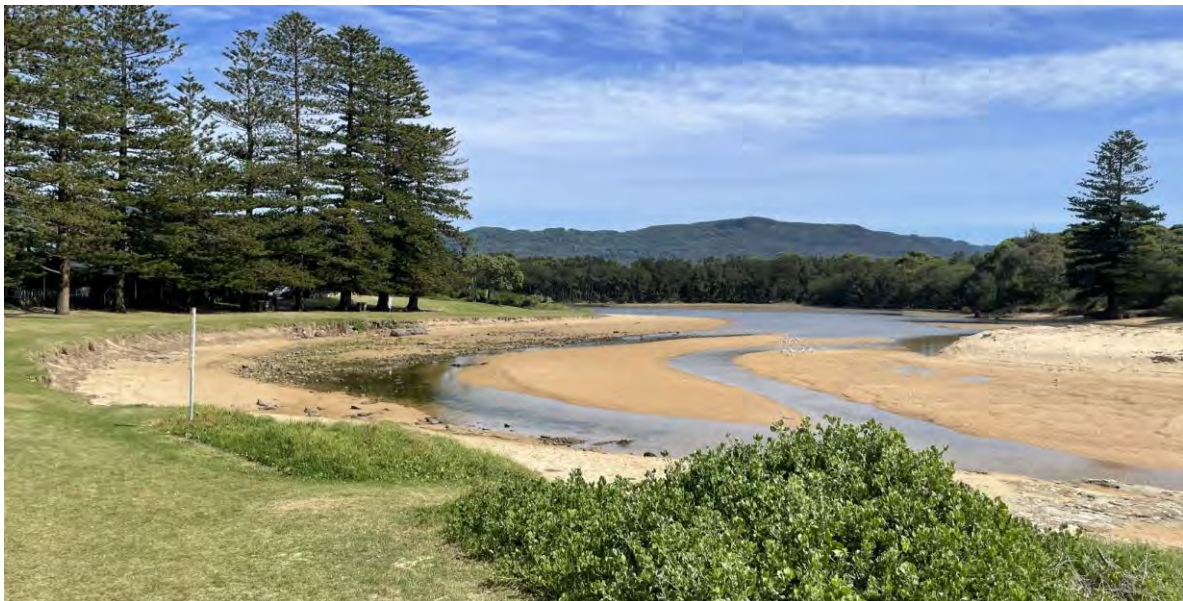
Figure 3.50 Bank erosion across the entrance of the Fairy Creek waterway

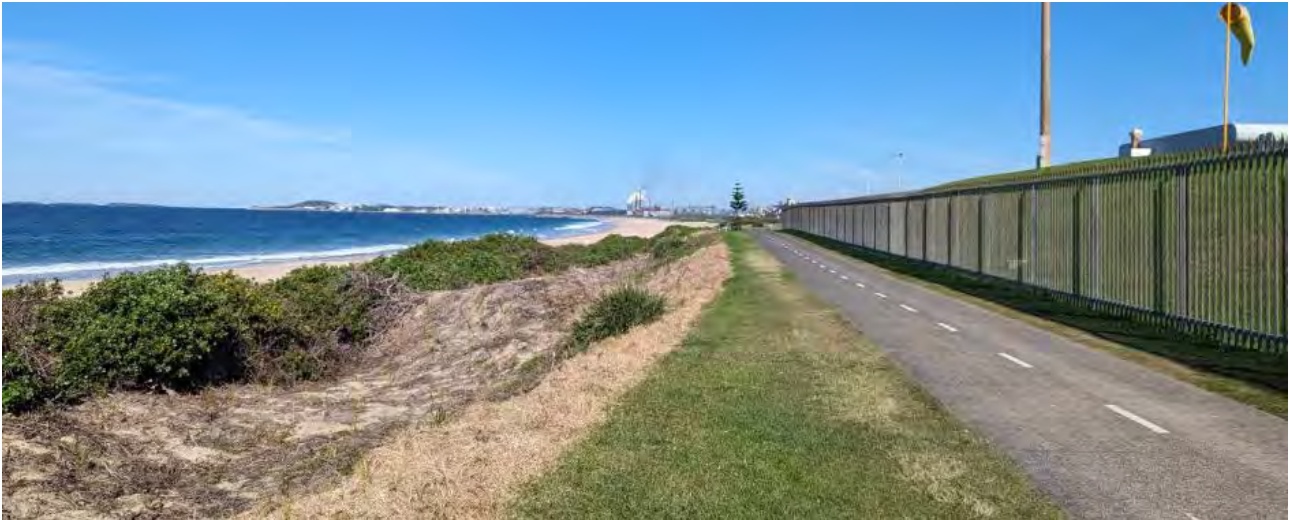
Figure 3.56 Weed removal and replanting of native dune vegetation in front of WIN Stadium (image source: Salients, 2026)

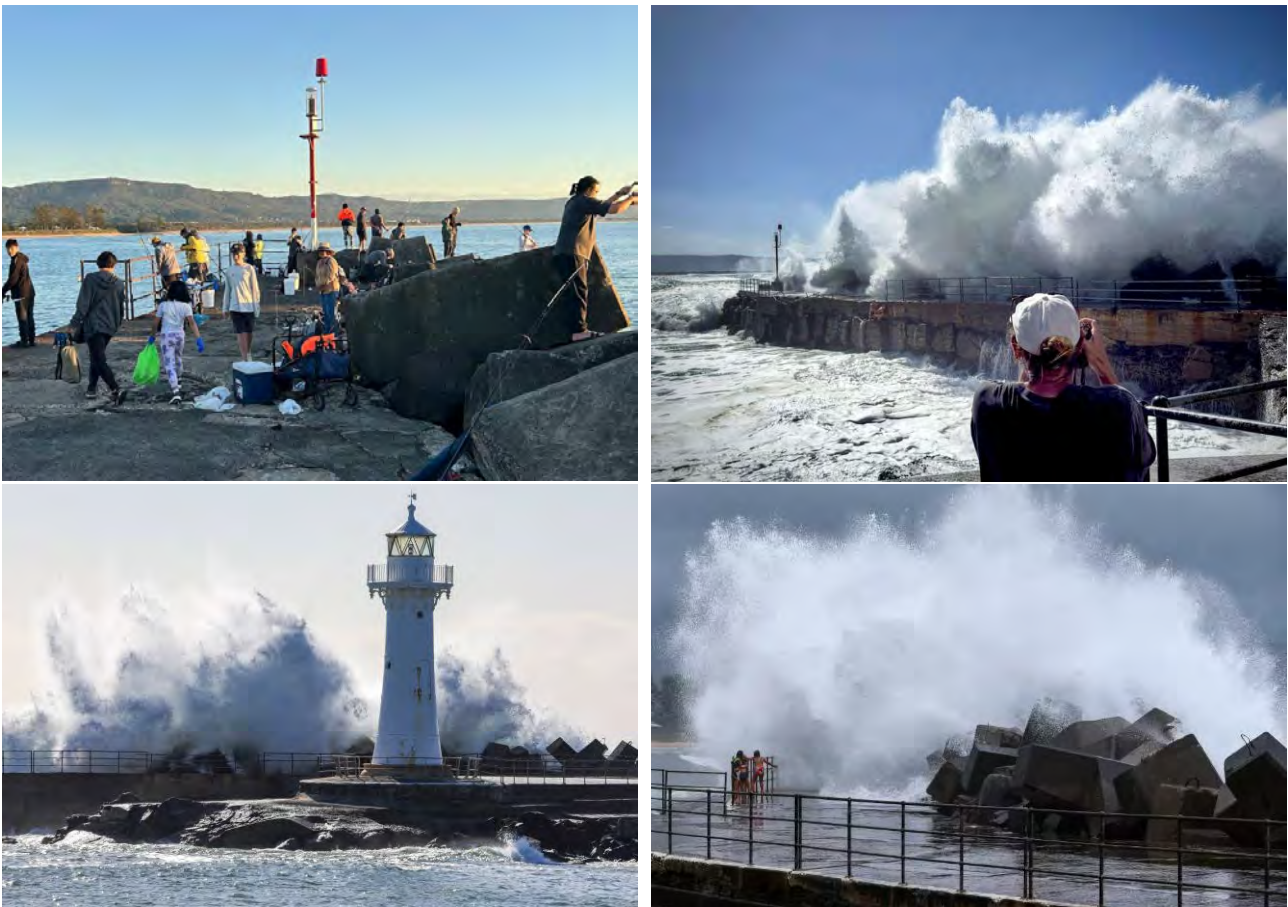
Figure 3.58 The Harbour breakwaters are popular recreational access spot, but are also subject to periodically dangerous wave overtopping (image sources: The Illawarra Flame)

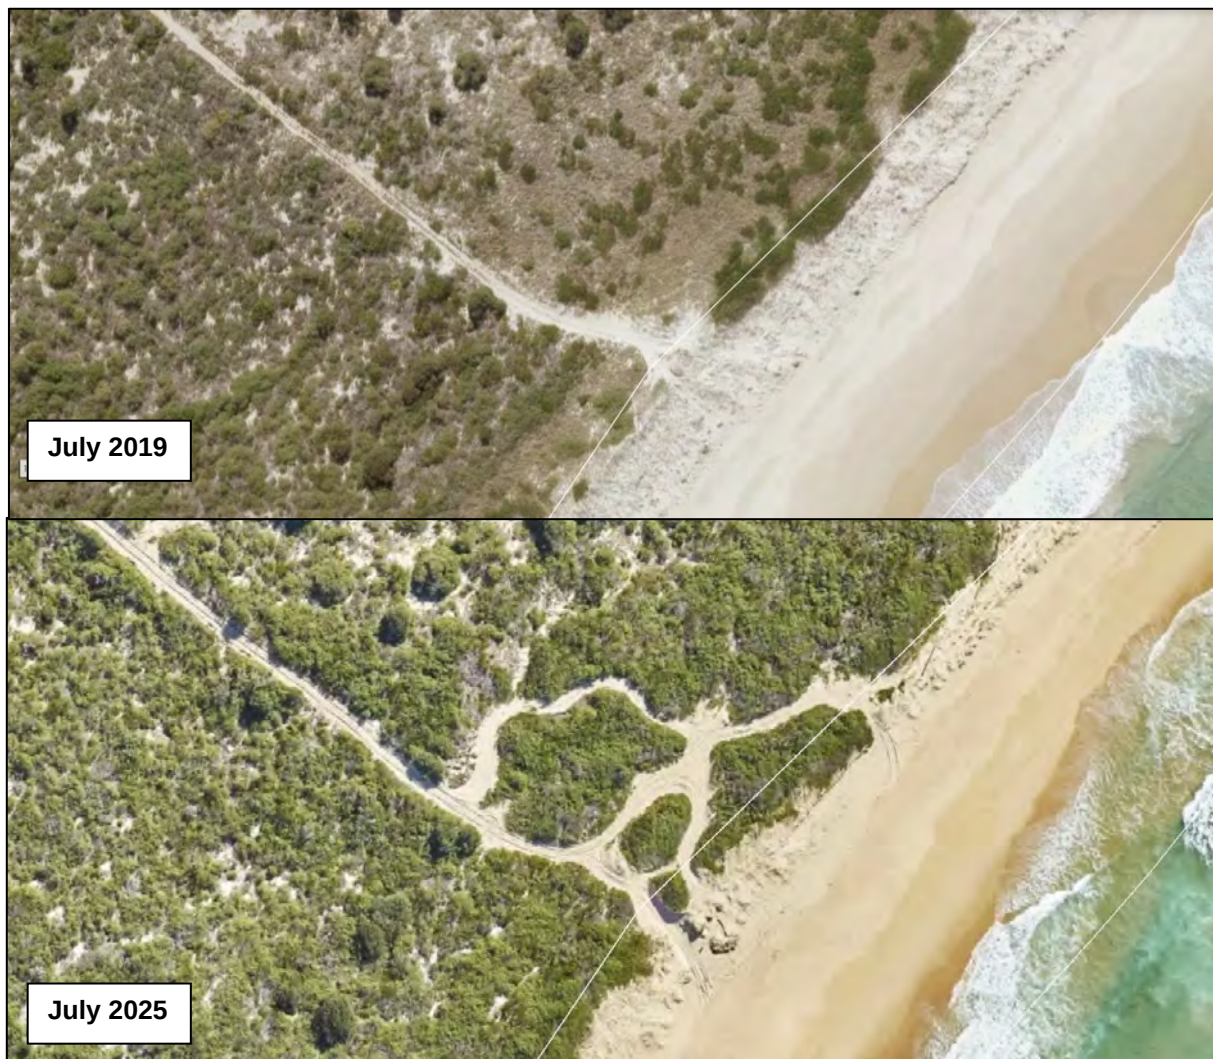
Figure 3.64 Four wheel drive impacts observed at Perkins Beach between 2019 and 2025 (image source: MetroMap)

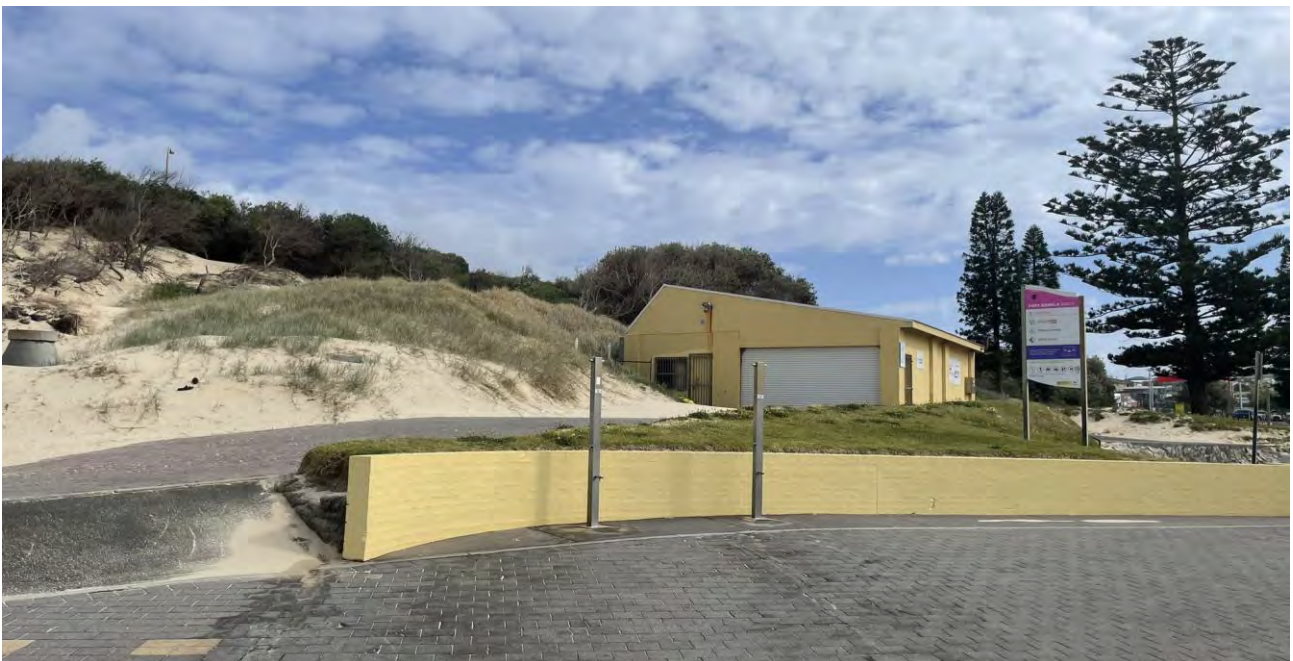
Figure 3.65 Wind-blown sand blocking a SLSC storage building at Port Kembla Beach
